An Approach to Conservation and Presentation of the Terrazzo Map Pavement of the New York State Pavilion in Queens, New York

A Thesis in Historic Preservation Presented to the Faculties of the University of Pennsylvania in Partial Fulfillment of the Requirements for the Degree of Master of Science in Historic Preservation 2007. Advisor: John Hinchman

CHAPTER 4: CONDITIONS ASSESSMENT

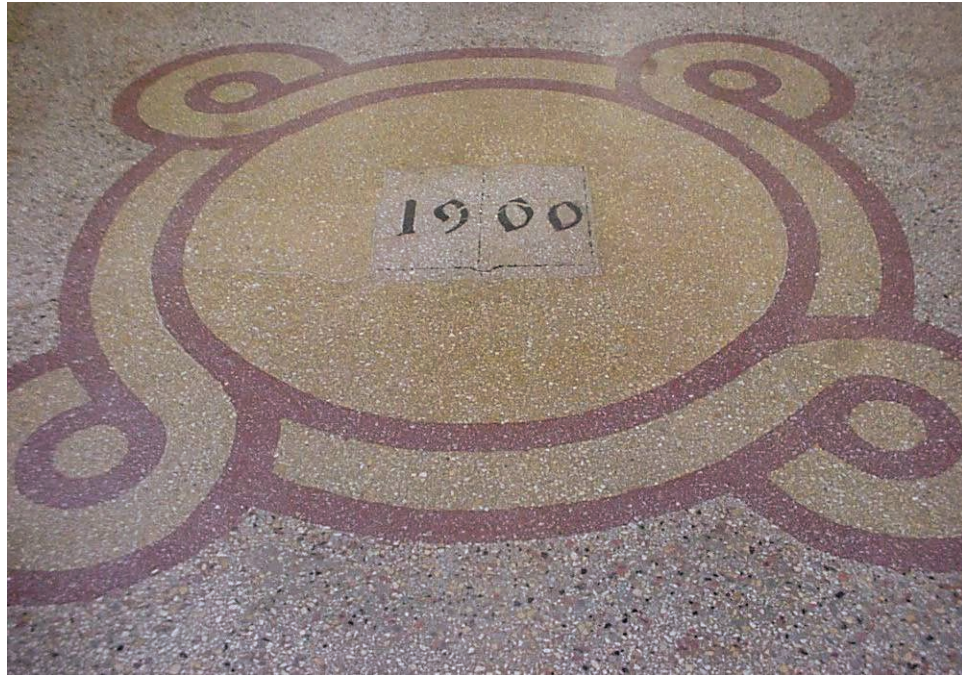
Figure 5: Before restoration of the terrazzo in St. Joseph's Library, St. Joseph Missouri.

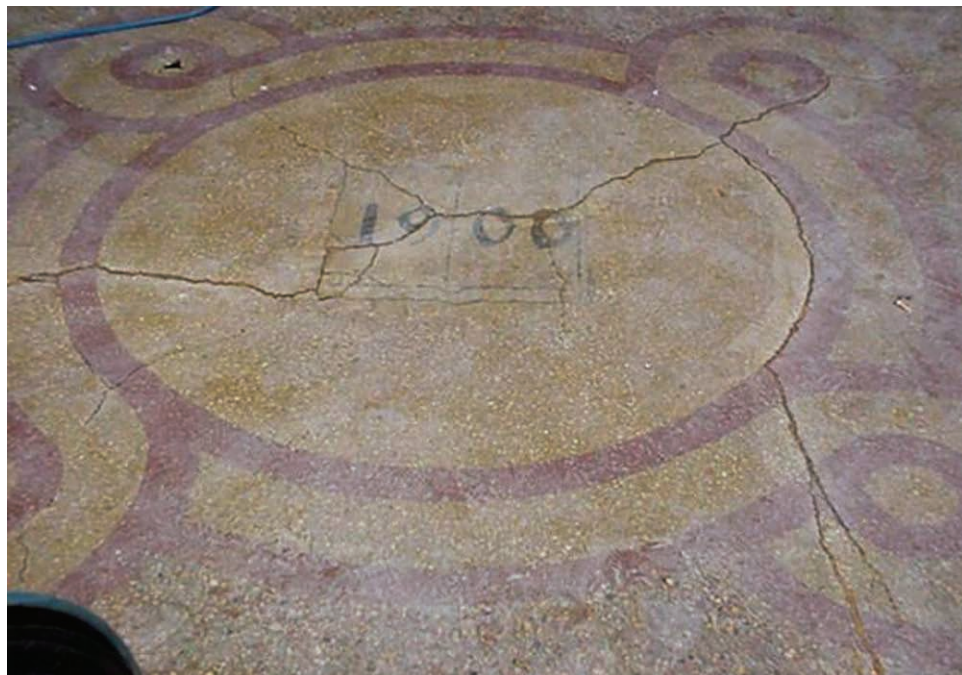
Figure 6: After restoration of the terrazzo in St. Joseph's Library, St. Joseph Missouri.

damage while bringing out the colors and pattern of the original design. While the repairs are still slightly discernable, the intention was to emphasize the original floor, not the repair, and restore this original feature of the building. The techniques used for repair follow the procedure outlined on the NTMA website and discussed above. The goal was to match the original color and texture using a tinted matrix and marble chips that matched the size and color of the original floor. This approach to terrazzo restoration is a standard approach taken by companies that make repairs to damaged terrazzo and recommendations for repair as specified by the National Terrazzo and Mosaic Association.

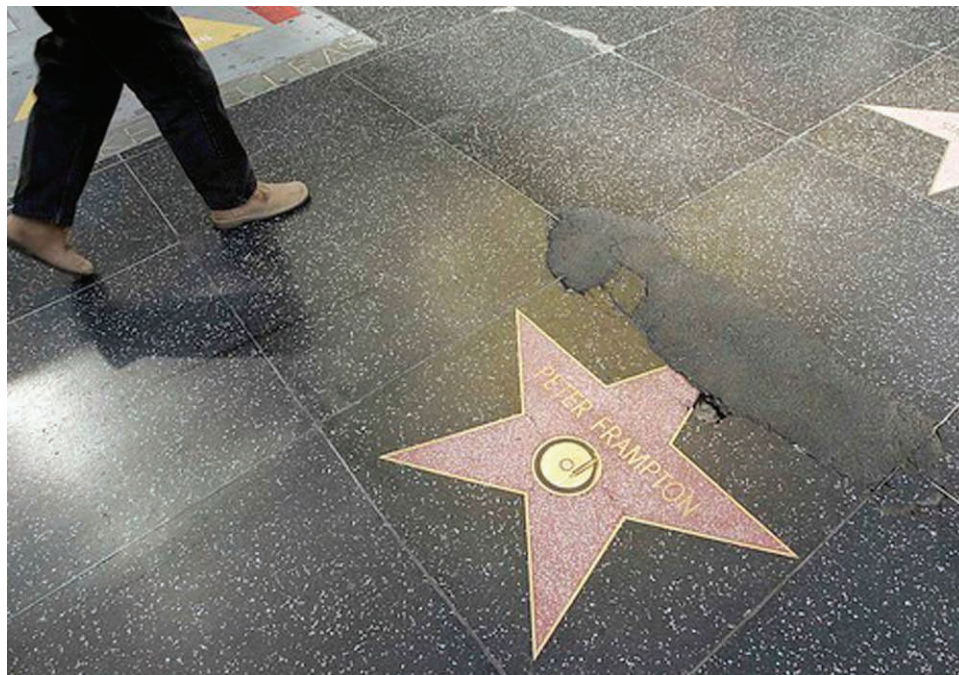
Beginning in 1994 with the construction of an underground metro line, the Hollywood Walk of Fame began to display cracking and “buckling”.²⁶ (Figure 7). Past and continuing damage from the metro, and potential thermo-expansion problems are the two opposing speculations as to the cause of the problem, but neither has been proven yet. While discovering the source of the problem is key to preventing future damage, the intermediate solution has been to replace the 121 damaged black terrazzo squares and an additional 16 that have stars in them, in time for the 2007 Oscars.²⁷

Figure 7: A damaged and patched terrazzo starr from the Hollywood Walk of Fame.
Source: Loss Angeles Times, February 9, 2007. <http://www.latimes.com/news/local/la-me-stars9feb09,1,3826359.story?page=2&cset=true&ctrack=1&coll=la-headlines-california>

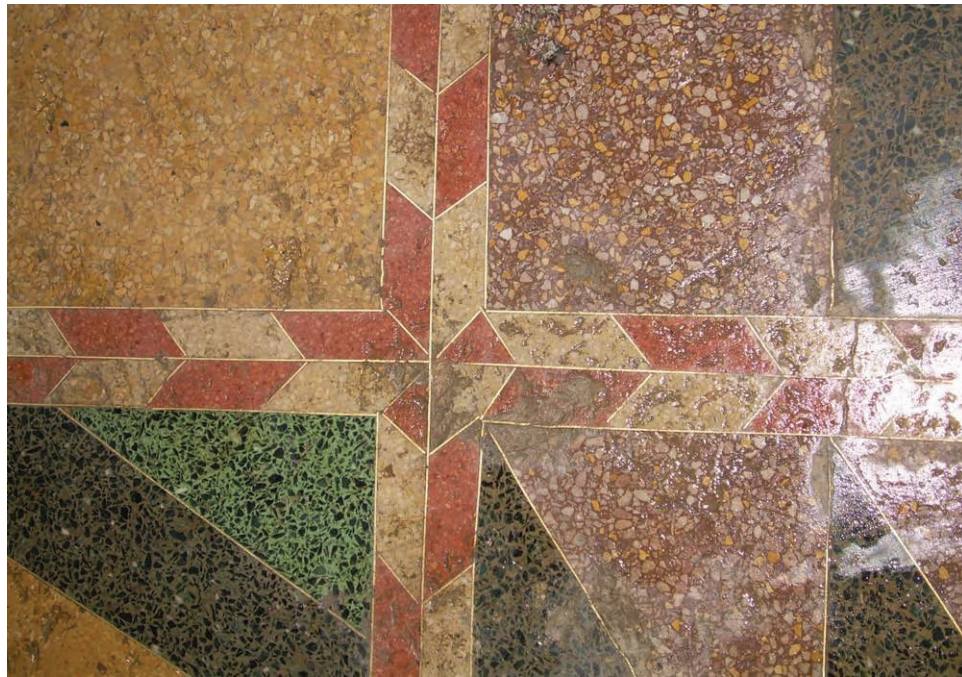
The interior terrazzo floor had been covered by carpet prior to restoration and the damage consisted of various size holes, some of which were drilled into the floor to accommodate pipes, cracks that penetrated the terrazzo topping, pitting, and fine cracks. (Figure 8).

Figure 8: The terrazzo floor in the lobby of the East Columbia Building before conservation.
Source: Andrea Morse, Sculpture Conservation Studios.

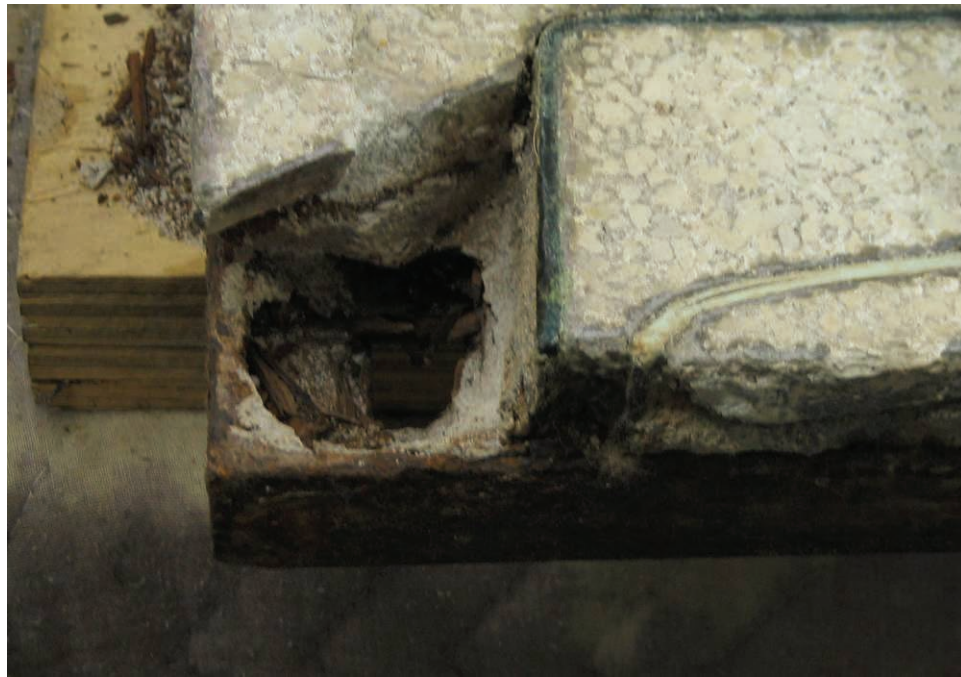
Figure 14: Detail of a damaged terrazzo tile showing the metal frame, terrazzo, underbed and a hold where the plywood support has rotted. Source: Photo by author.

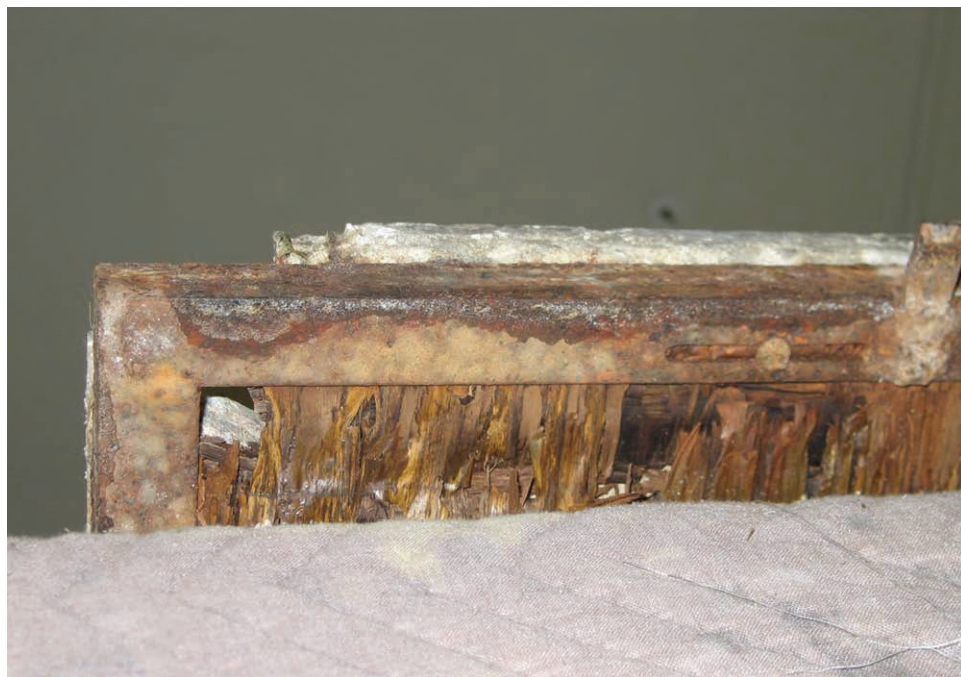
Figure 15: View of a terrazzo tile from below with rotting plywood. Source: Photo by author.

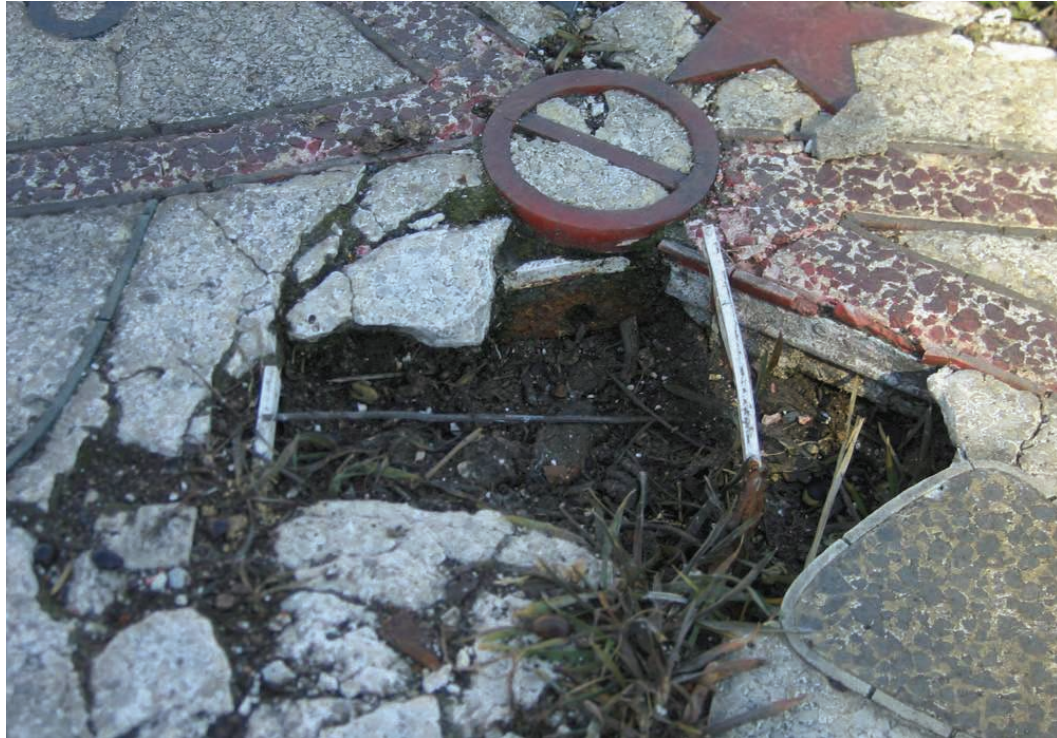
Figure 16: Detail of the insets and support system in a damage tile on site. Source: photo by author

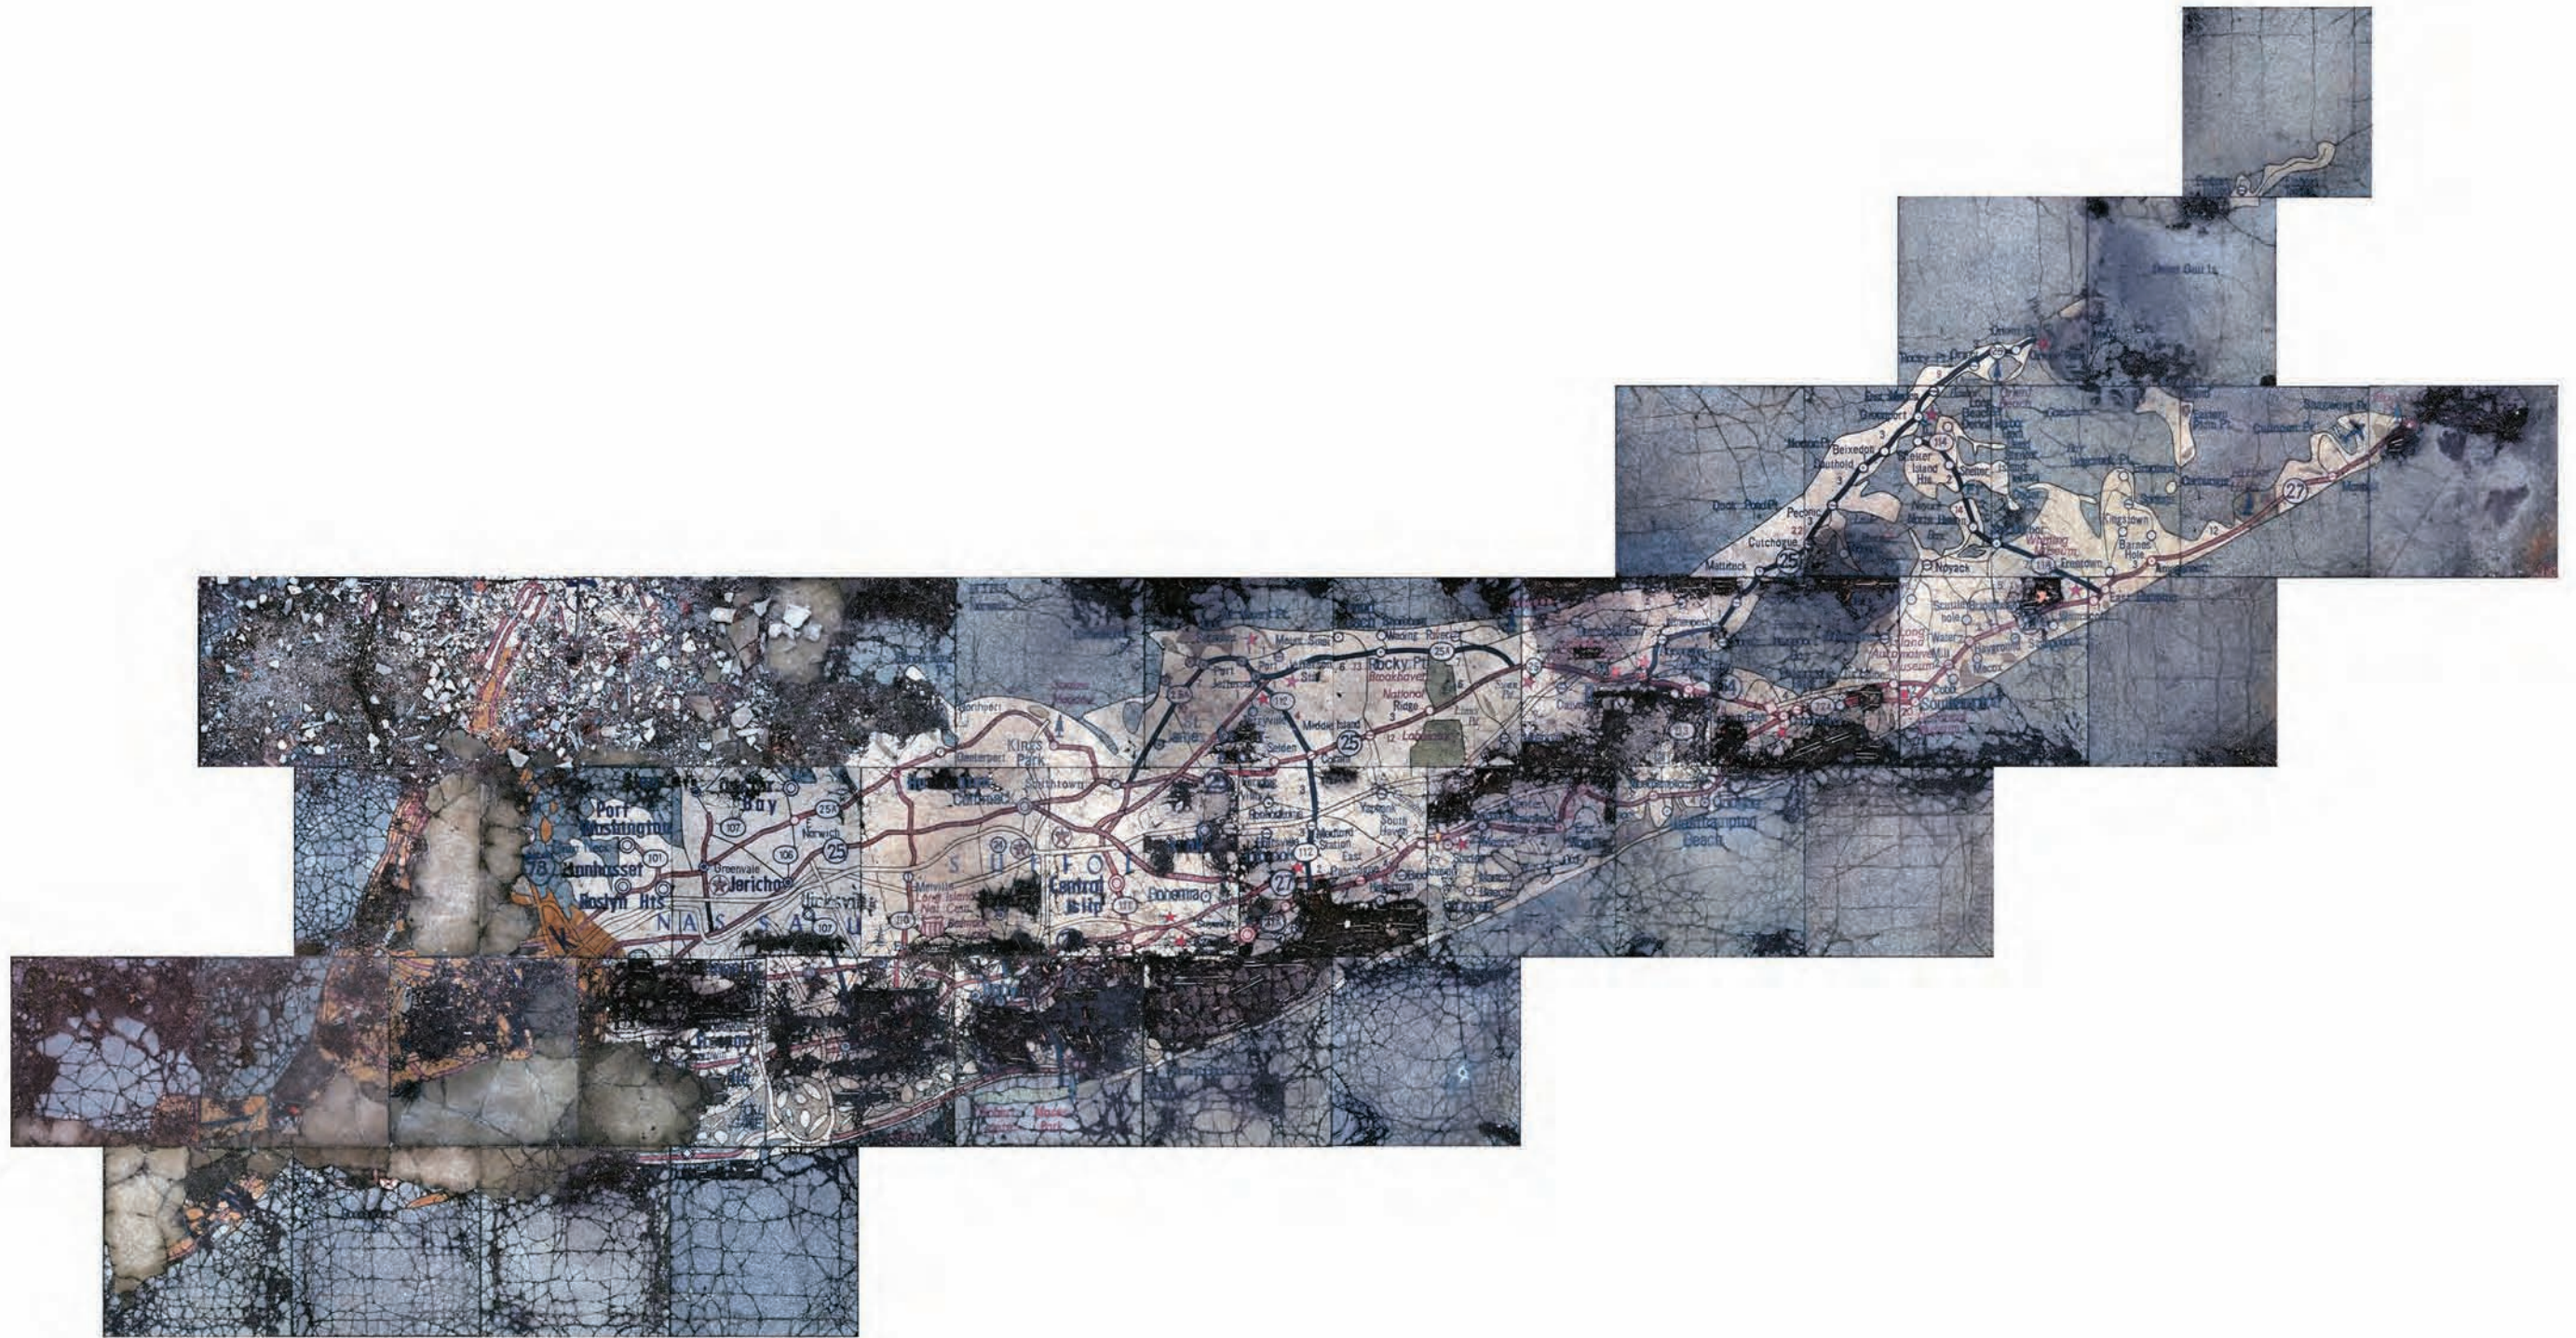
The 40 Terrazzo tiles that comprise the Long Island section of the terrazzo pavement. Photos by John Hinchman, November 2006.

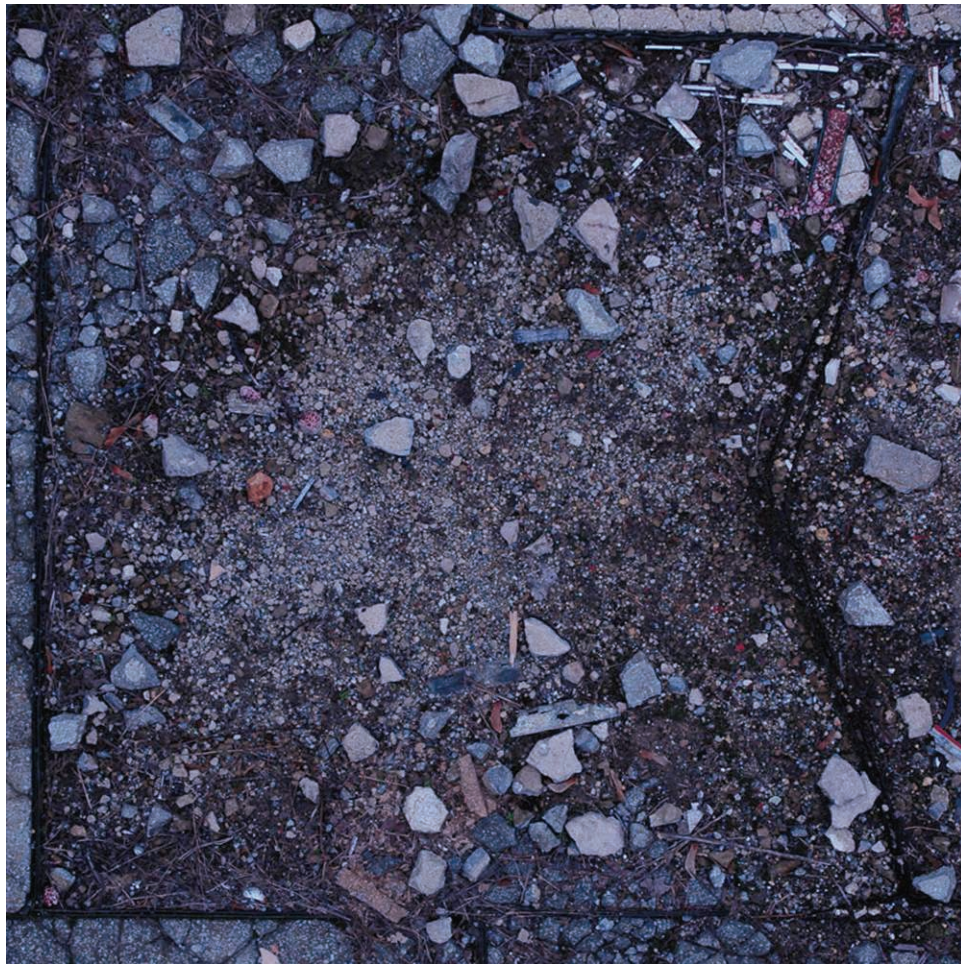
Loss: The absence of terrazzo or plastic insets revealing the substrate below.

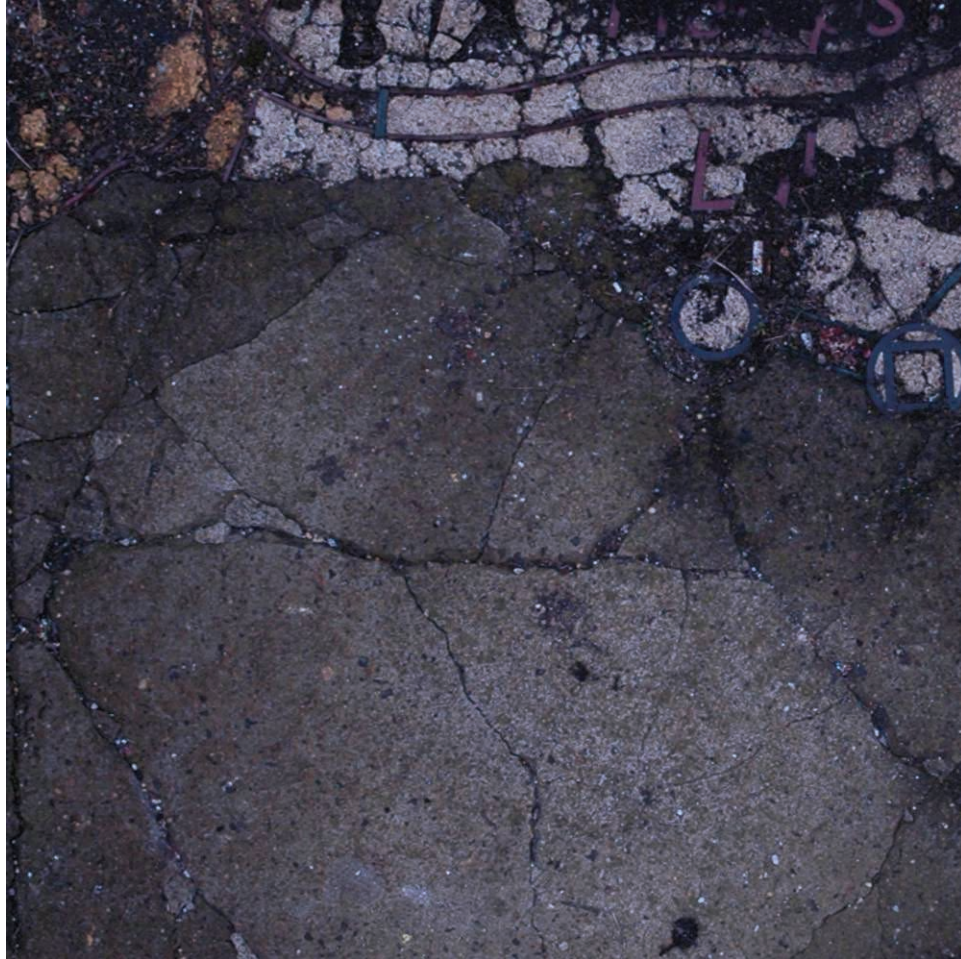
Fill: The presence of cement that filled a previous area of loss.

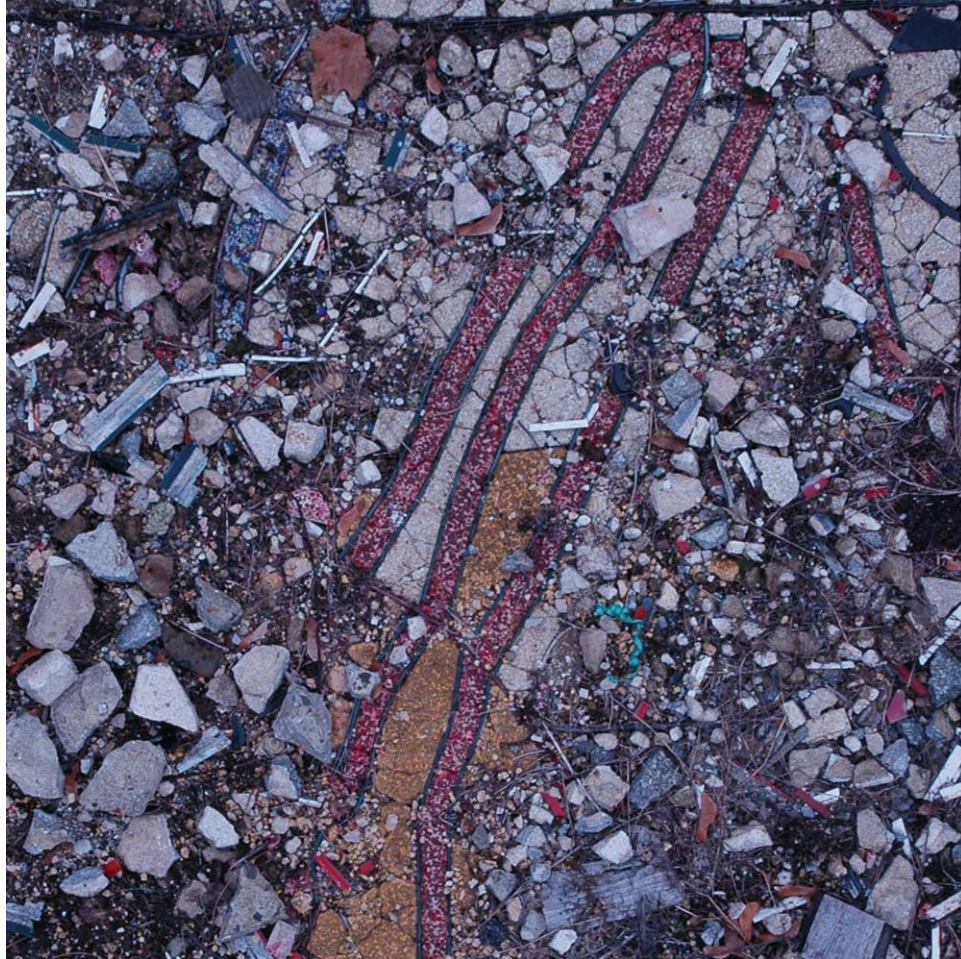
Incipient Spall: Terrazzo that has begun to detach from the panel but still remains connected. Often seen in association with loss, cracking, debris, and vegetation.

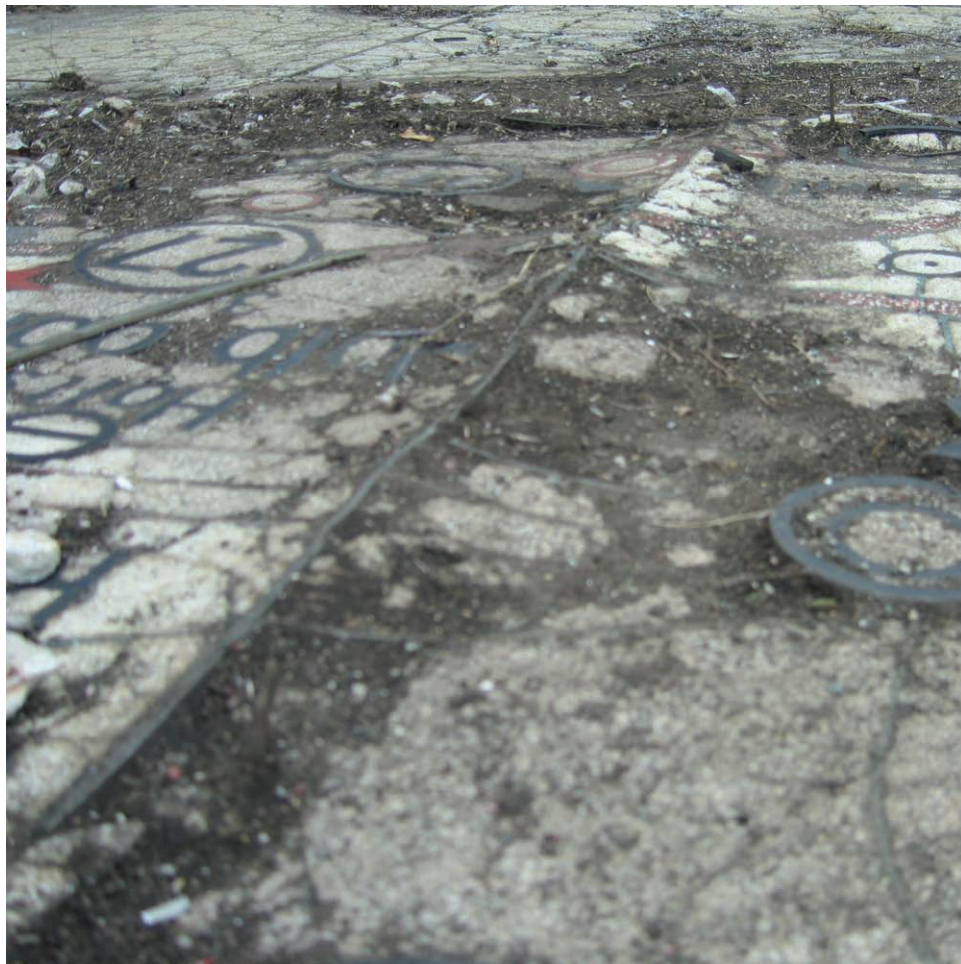
Deformation: Deformation is characterized by the concave warping of the panel, whereby the center is lower than the perimeter edge.

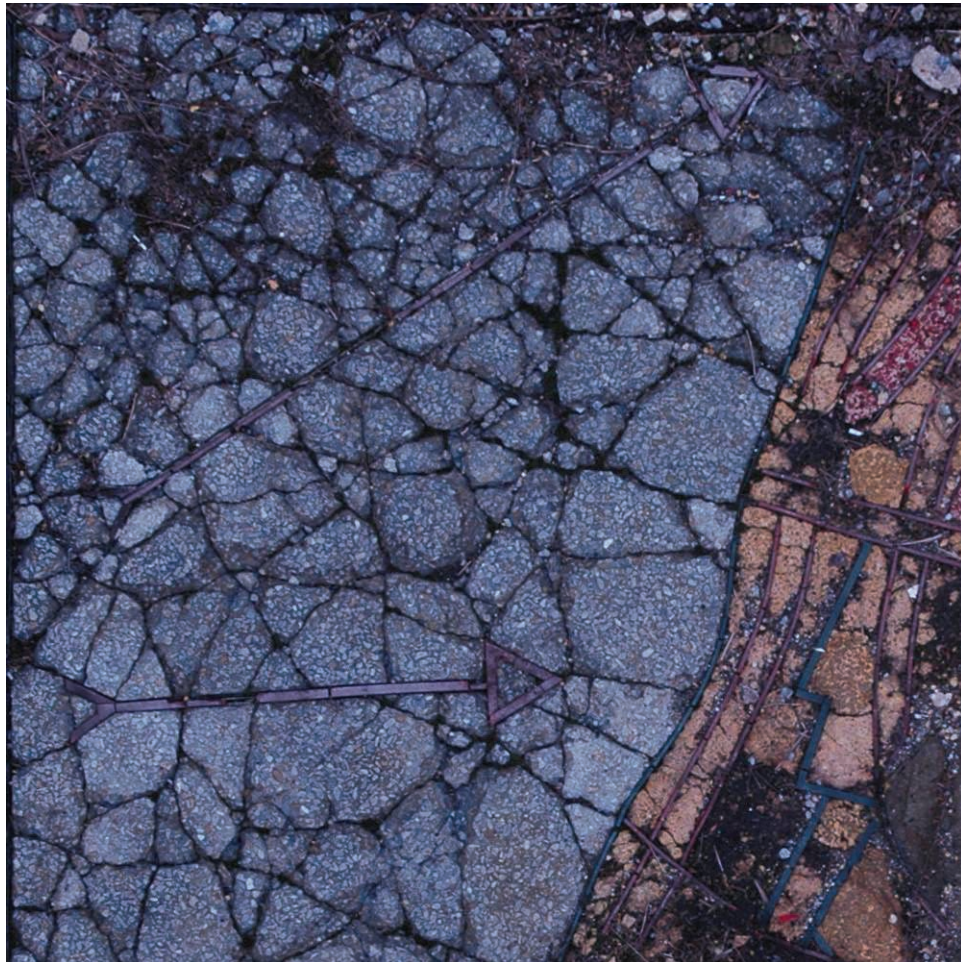
Severe Network Cracking: Cracks that have penetrated the terrazzo topping, forming “islands” of terrazzo. Deformation is often seen in conjunction with this condition.

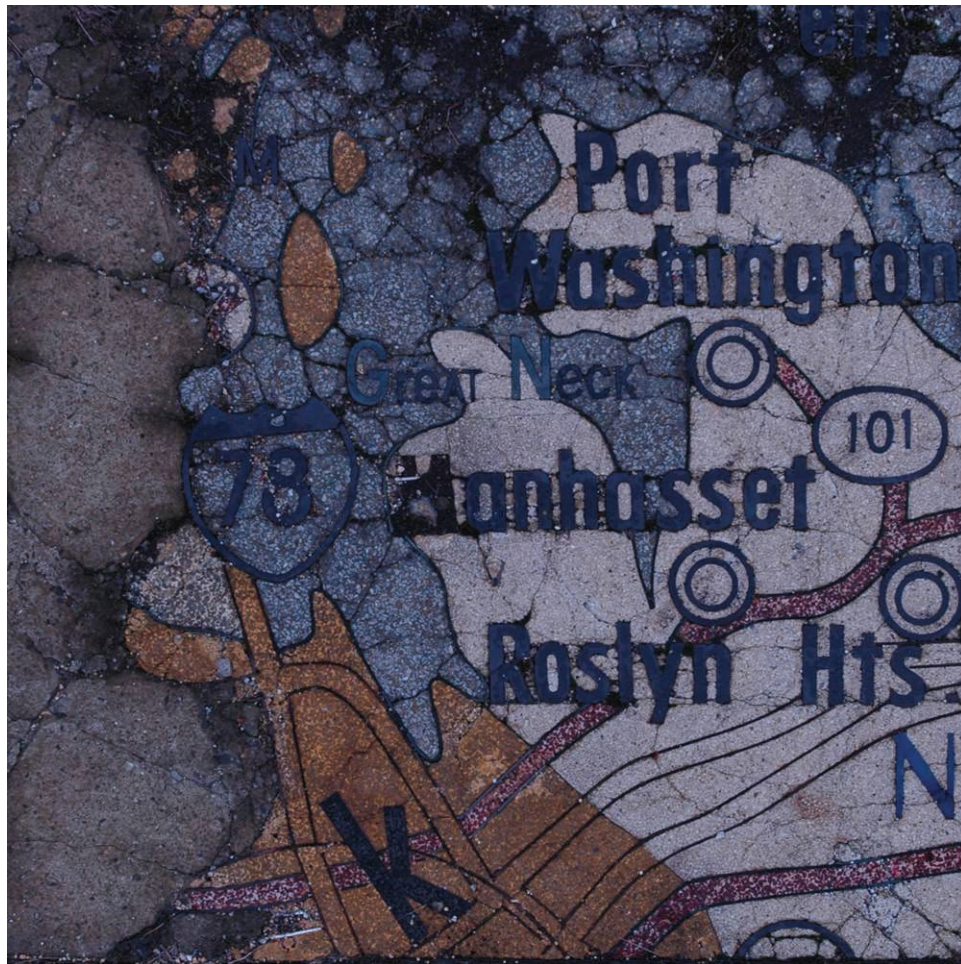
Moderate Network Cracking: A network of cracks that penetrate the terrazzo but where the integrity of the terrazzo and overall imagery are still in tact. Cracks are deeper than the minor network cracking but do not create “islands” of terrazzo like severe cracking.

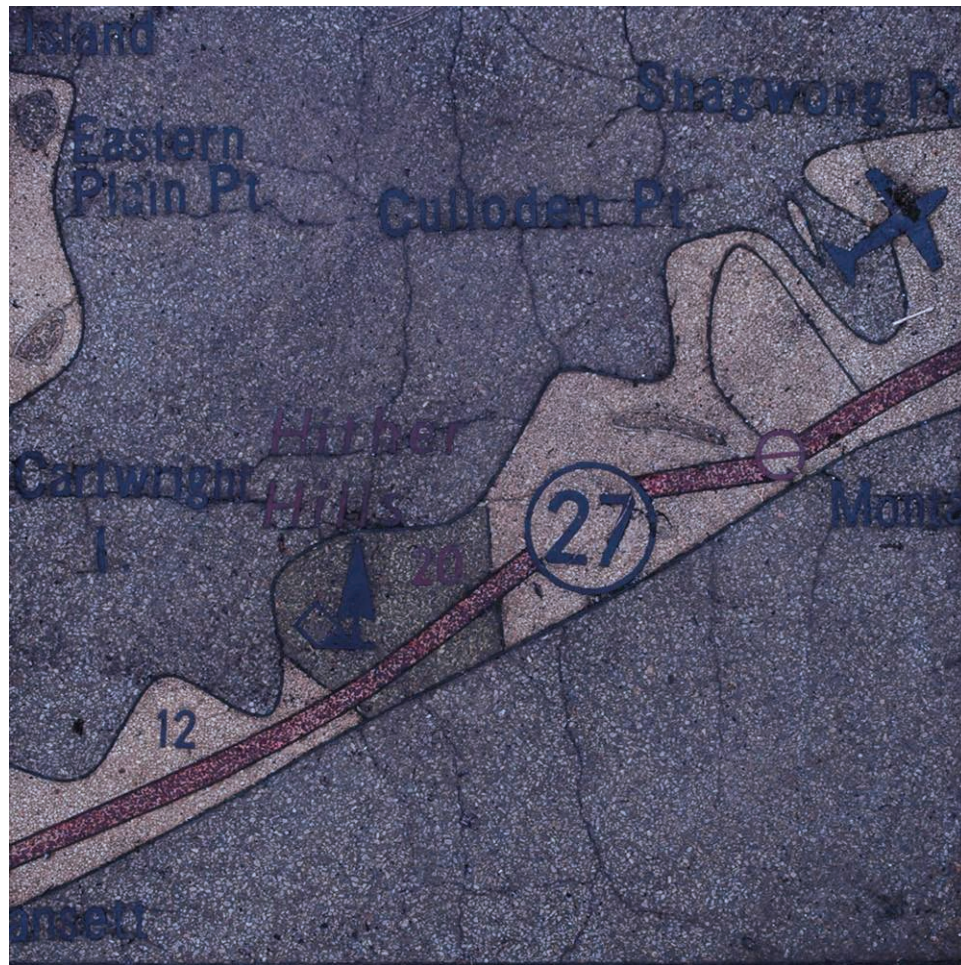
Minor Network Cracking: Cracks that remain close to the surface of the terrazzo and do not contribute to deformation of the panel.

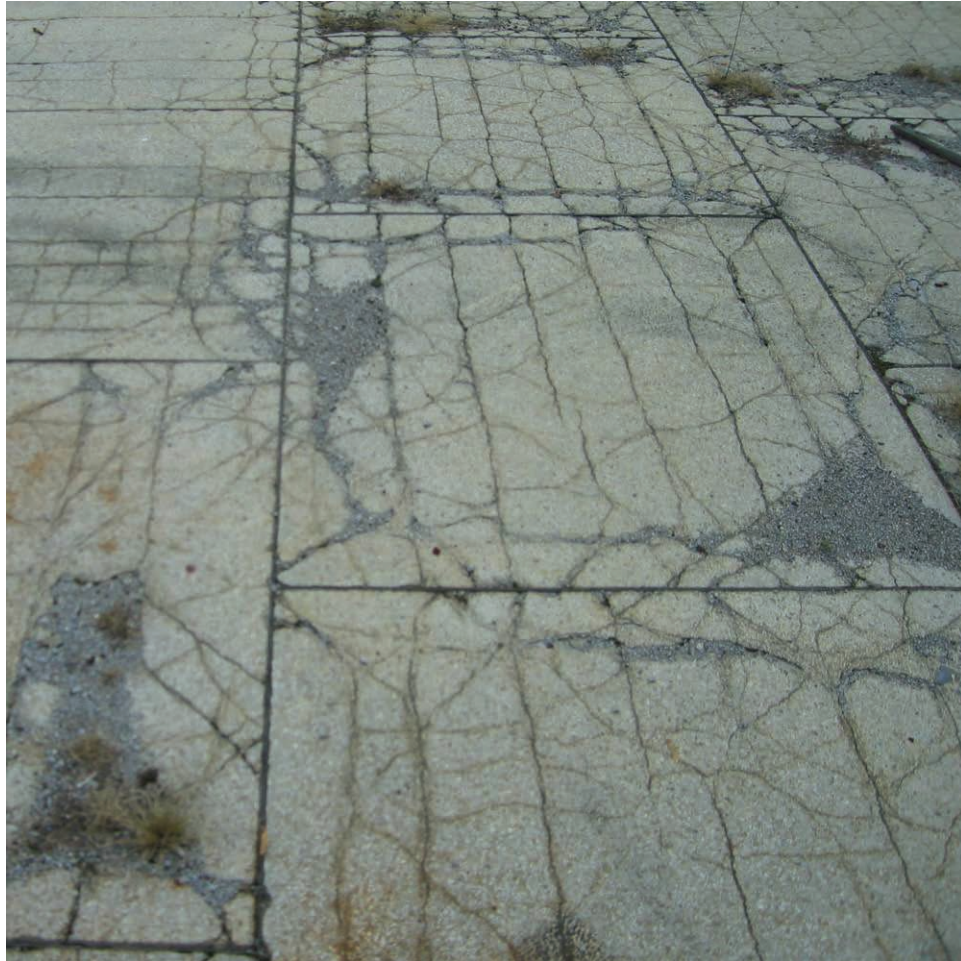
Parallel Cracking: Cracks that appear parallel to each other and the edges of the tile.

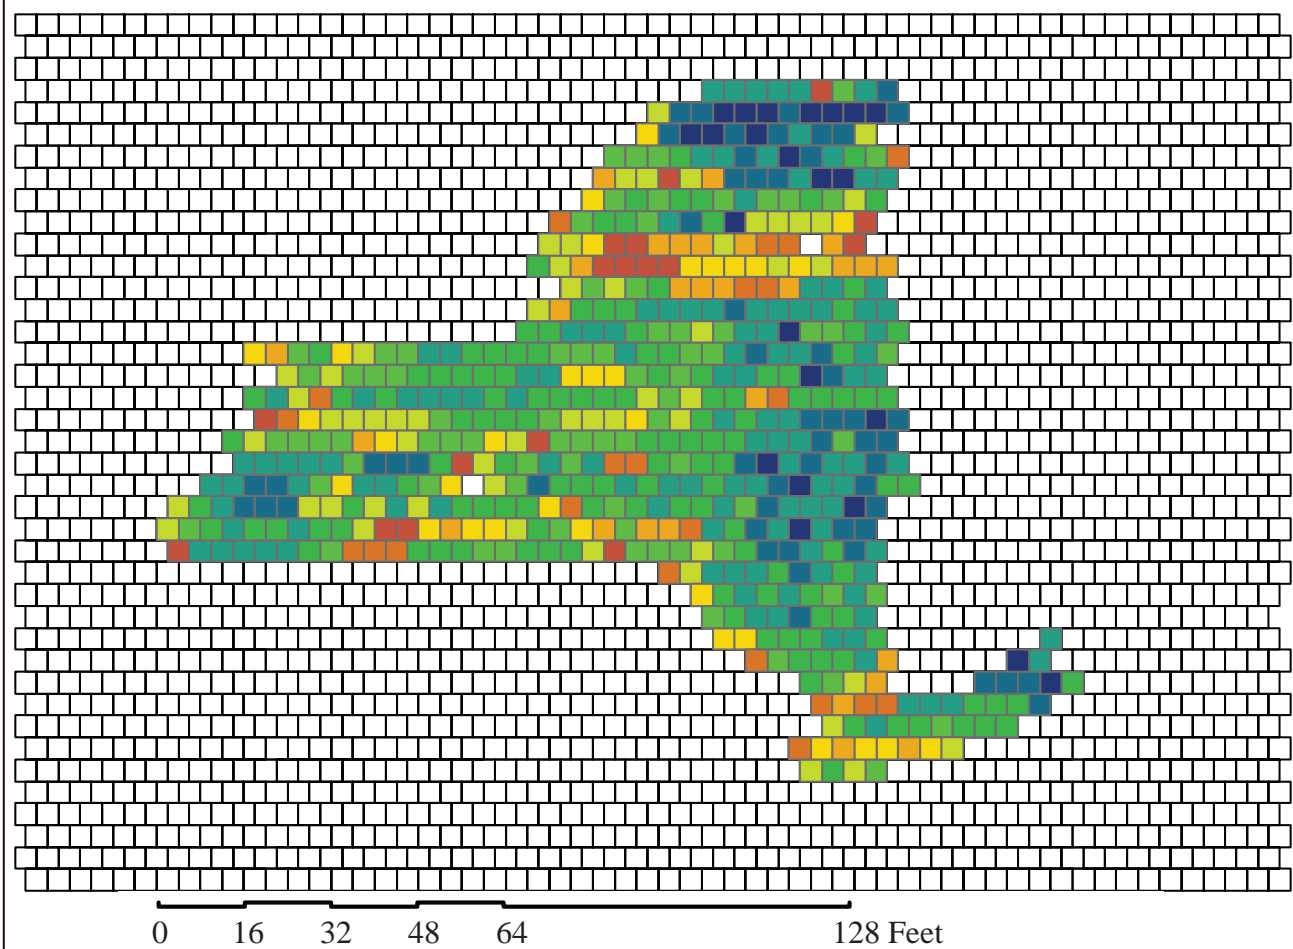
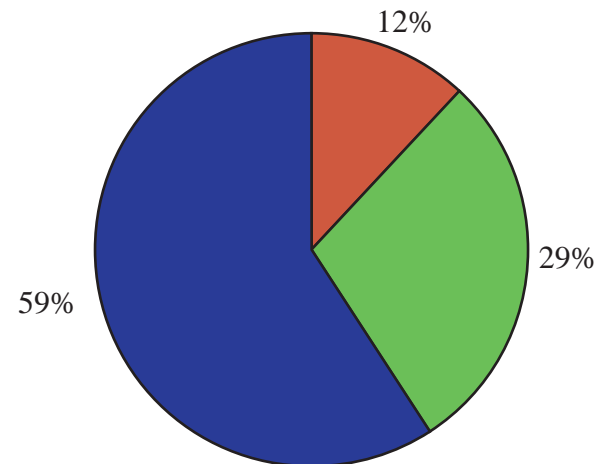
Map 1: Overall Conditions of the 567 tiles of New York State.

All 567 tiles within New York State were given a value on a scale of 1-10. No tiles were given a value of 10, but all the other numbers are represented. The values represent the overall condition of each tile based on the integrity of the existing material and the severity of loss and damage. A value of "0" indicates tiles that have been replaced with cement.
